Quest Engineering & Failure Analysis, Inc. www.quest-engineering.com

Re: Rebuttal Report

File: Bryson Accident

Quest No: 10519

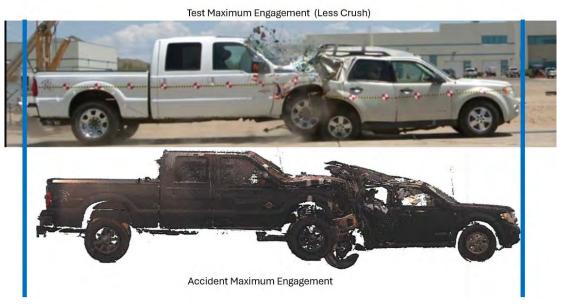
Figure 2: Comparison of Maximum Engagement

The point of maximum engagement between the **test** vehicles is in the crash test video. When comparing the crash test to the 3D model of the **accident** vehicles at maximum engagement, there was less penetration into the rear passenger compartment than on the accident Escape (*Figure 2*).

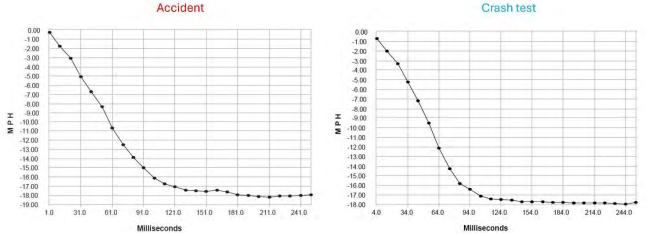
Figure 7: Longitudinal crash pulse comparison

As identified above, the crash pulses of the **test** F250 and the **test** Escape can be compared with respect to generally accepted principles of classical physics and accident reconstruction. The two F250 crash pulses are shown below (*Figure 7*). In engineering, the rate of change of velocity is the acceleration and by Newton's Law of Motion is directly related to the applied force. Thus, the steeper the crash pulse, the greater the applied force. Since the test "change of velocity pulse" verses "time pulse" is steeper, it represents greater deceleration of the **test** F250 per unit time and thus greater applied force on the front of the truck to slow it down faster. The source of this force is, of course, the presence of the **test** Escape. Because there is a greater force in the test, the **test** Escape was stronger in the region impacted than in the accident even though there was less of the Escape available directly in front of the **test** F250 to resist the truck (because of the offset problem shown above). The steeper crash pulse does demonstrate that when impacted at the lower elevation, the Escape provides more resistance and therefore is stronger and because energy is the product of force and distance, the crush distance mathematically must be lower. Thus, just from the accelerometer data recorded in the **accident** and **test** F250's, and using physics, the lift kit resulted in an increased amount of **accident** Escape crush when compared to an impact with a non-lifted F250. The calculations are as follows:

- Accident F250 Crash Pulse slope from 31 ms and 5.10 mph to 91 ms and 14.96 mph is -7.5 g's
- Test F250 Crash Pulse slope from 34 ms and 5.24 mph to 94 ms and 16.42 mph is -8.5 g's
- **Test** Deceleration Minus **Accident** Deceleration equals one G (the weight an F250 or about 8500 to 9000 pounds)

Thus, when the lift kit was removed from the F250, the **test** Escape was able to generate about 8,500 to 9,000 pounds more force to resist crush than when struck by a lifted truck because the bumper level structures of the Escape were better engaged as it was a bumper-to-bumper level impact. The actual increase in resistive force would have been higher had the offsets been proper because there would have been more lateral overlap by 5 inches and thus even more of the Escape structure would have been directly engaged.
